Canon 814XL "fps" dial repair 2.

I received an 814XL for repair. No matter where I set the speed dial, it only does stop motion. It was working fine until the other day. It seems like it's going to break in a certain place...

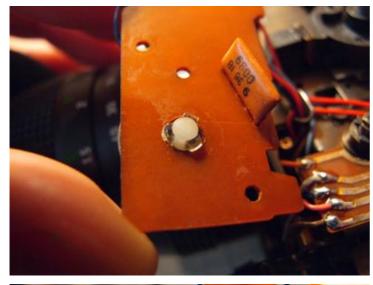
It is stopped it with a plastic pin in this way.

It withdraws a pin and a plastic dial is removed. It breaks mostly because a plastic dial is fragile .

So, this dial is repaired and reinstalled.

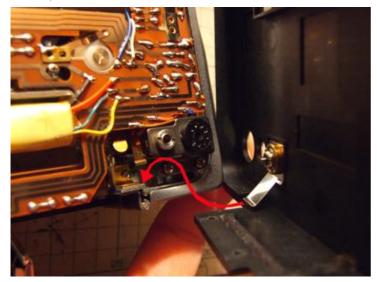
It is necessary to fix the contact part of the flash terminal. It is not easy to fix it very much. In that case, the flash terminal doesn't work though the side cover adheres even if this is not fixed. Oh dear, I will assemble it neatly though it is not thought that it uses

This is an attention point when assembling.
